ACCIDENT INVESTIGATION REPORT
INVOLVING HELICOPTER G-DKEM
IN THE FANARI AREA, MYKONOS
ON 4 MAY 2016

E 03 / 2017

**Helicopter G-DKEM, BELL 407
at a private landing field in the Fanari area, Mykonos, on 4 May 2016**

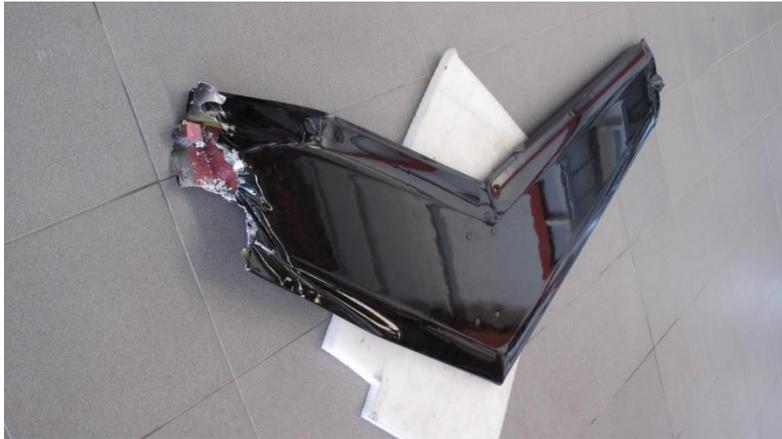
Following the safe landing, the pilot carried out check which revealed that the tail skid and the lower part of the tail fin were missing from the helicopter, these were found at the rear of the adjacent wall. In addition, there was serious damage to the tips of the tail rotor blades, which showed traces of red. On the east side of helicopter landing field where there is a wall 1.6 m high, there were traces of contact (a red mark) with the tail section of the helicopter, approximately 10 cm below the top of the wall. The CAMO EL.MG.0034, responsible for its airworthiness, had the helicopter transferred by truck to the hangar of the maintenance organisation EL.145.0051, contracted for its maintenance, for further check.

Photo 1 – Tail fin

From the subsequent inspection of the helicopter and the existing photographic material, it becomes clear that on contact of the tail skid with the wall, the lower part of the tail fin became skewed and then, as it touched the tail rotor blades where there are traces of red, the lower section of the tail fin was cut off. The contact between the tail rotor blades and the tail skid resulted in the tail rotor gearbox support breaking. This led to the vibration reported by the pilot.

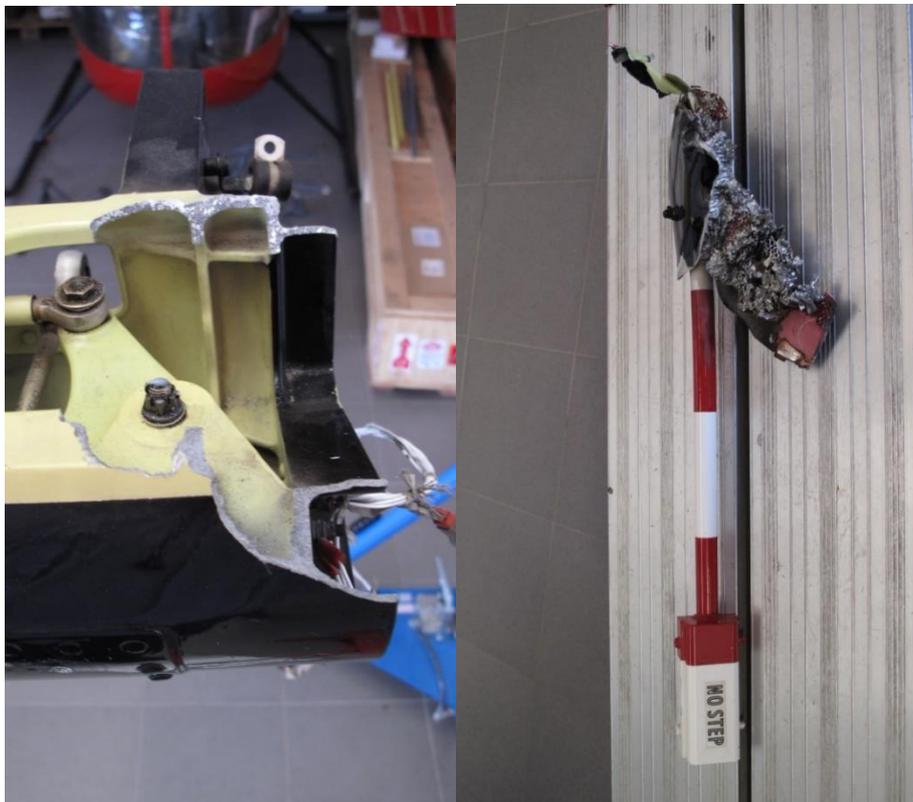
During the inspection, in addition to the aforementioned damage, the tail rotor gearbox support was found broken.

Photos 2 –3 Tail rotor gearbox support – Tail skid

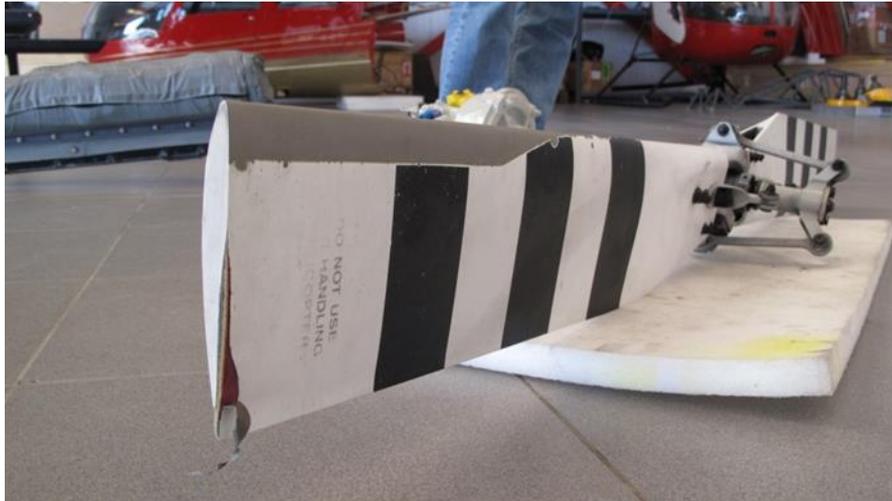
Photo 4 – Tail rotor blades

Furthermore, a pin from the tail rotor blade had broken off and pierced the aerodynamic fairing of the cabin and the frame beneath the helicopter's tail section.

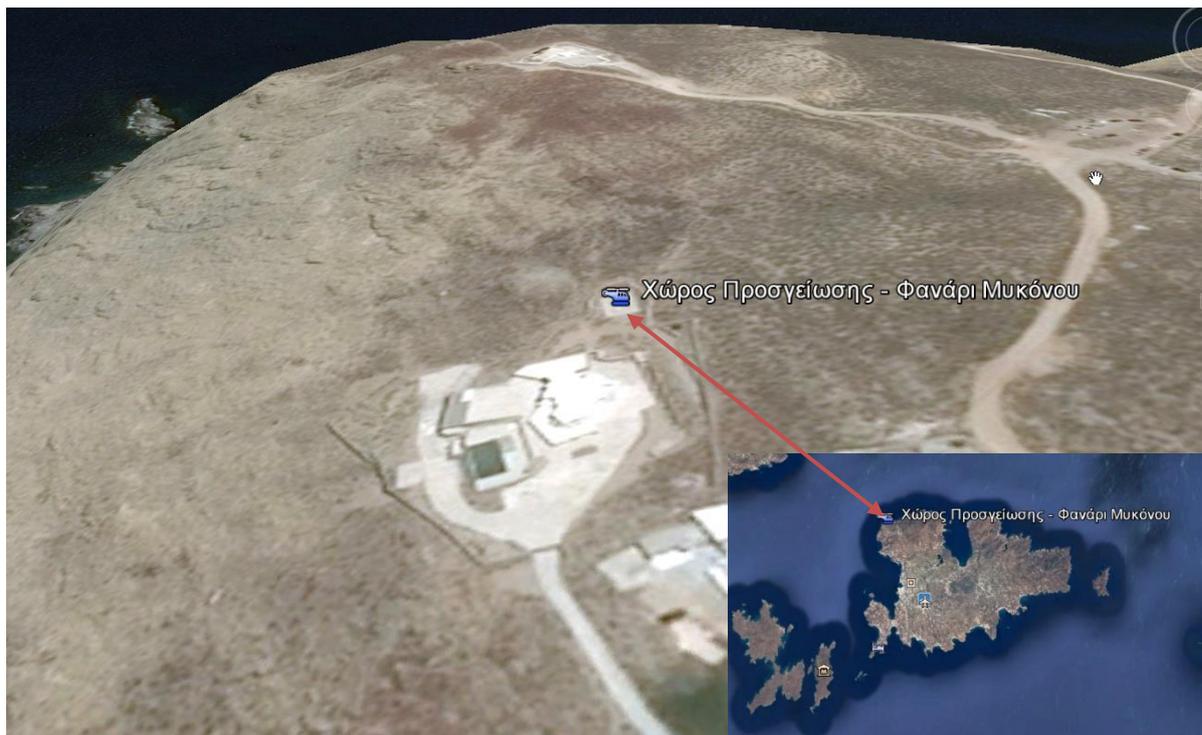
Figure 1 – Helicopter landing field, Fanari, Mykonos

The helicopter landing field is located on property owned by the helicopter pilot and owner and is surrounded by a wall on three sides. On the eastern side the wall is 1.6 m high and on the other two sides (northern and western), it is 0.5 m high.

The length of the helicopter is 10.4 m, while the distance of the eastern wall that was hit by the tail fin and rotor is 8 m from the centre of the landing field (designated area). From these dimensions it appears that the available space for rotary movement of the h/c is limited, namely if the centre of the h/c is rotated round by its axis accurately it leaves an available distance of about 2.8 m (8 m – 5.2 m) from the side wall. So if the operator of the h/c does not swing accurately and at a height that clears the surrounding obstacles (wall) the probability of hitting them is almost certain.

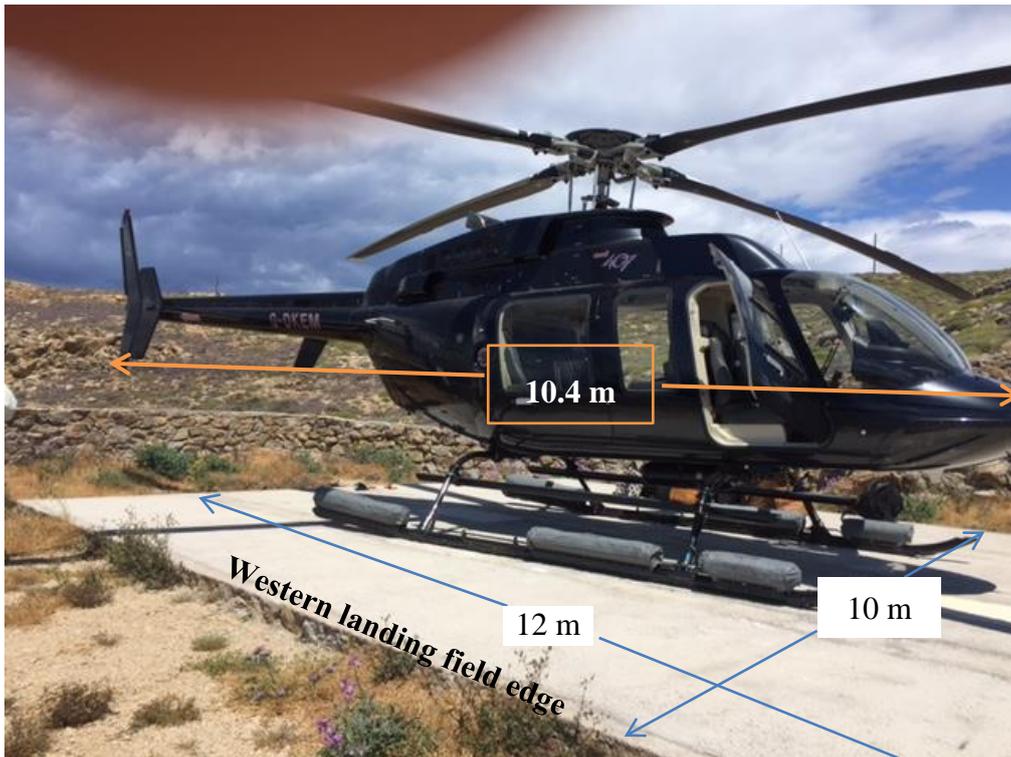
Photo 5 Helicopter on parking area following the incident
