**AIR ACCIDENT INVESTIGATION & AVIATION SAFETY BOARD**

**Incident Report of the a/c HB-JIC  
at Rhodes Airport “Diagoras”  
on 12<sup>th</sup> October 2008**

**Report No 08/2009**

Incident of the a/c HB-JIC of Hello AG  
at the apron of Rhodes Airport “Diagoras” on 12<sup>th</sup> October 2008

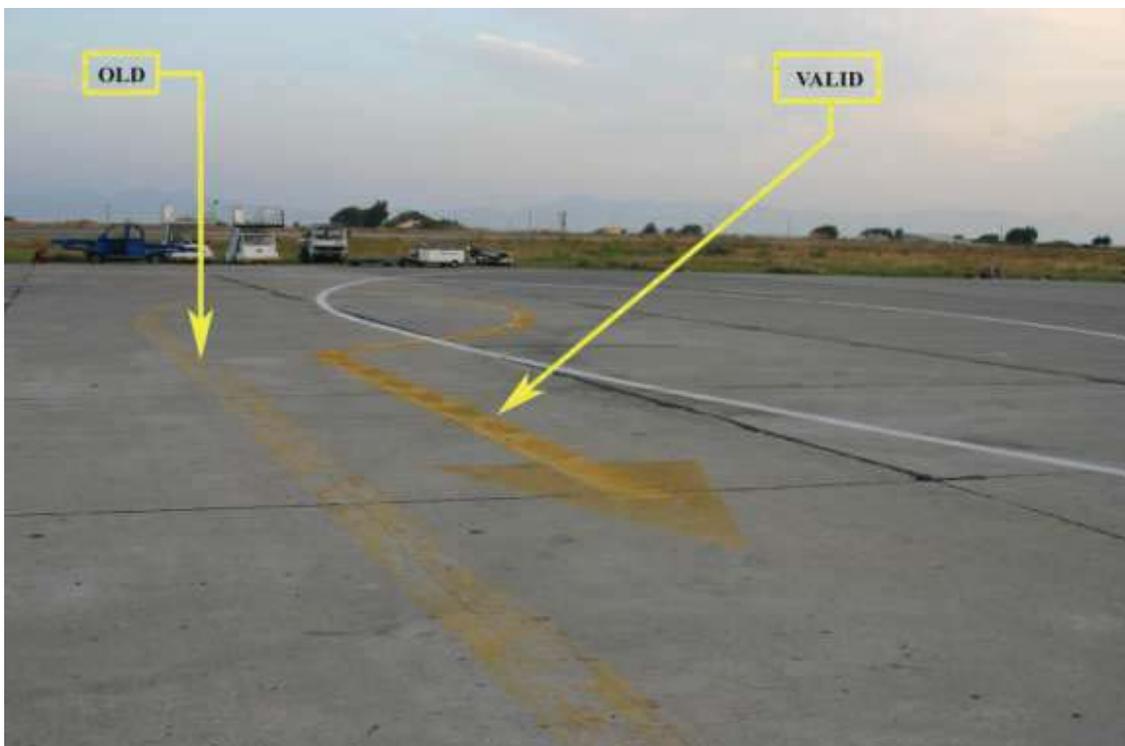
Picture 3 - Apron Lines – Position 9

The Apron floor markings consist of yellow and white lines. The white lines are the boundary lines of the airplane parking area and the yellow lines are for the airplane taxi guidance. It was observed that on the Apron floor, there are old yellow lines as well. These are almost faded out, but still visible, that under certain conditions, may be confusing, with the valid ones, by the crews. (Picture 3)

- 3.1.5.** In the Apron there are lines, those which are valid and are painted in bright yellow color and the old semi-faded which are not valid, that may confuse the Flight Crews.

- 4.2.1. 2009-09** Must remove immediately all the old lines and signals that are not in effect, not only in the Apron area but in all the areas of "Diagoras" Rhodes Airport.
- 4.2.2. 2009-10** Must take care in order for the aircraft service vehicles being parked in the areas assigned for this purpose, by the Airport Authorities.
- 4.2.3. 2009-11** Must implement the regulation HCAA/D3/B/28021/6495/19.07.07 “Checks in persons involved in the maintenance, preparation and flight of civil airplanes, for the ascertainment of alcohol and toxic substances or medicines in their organism” (Gov. Gaz. B/1380/03.09.07)

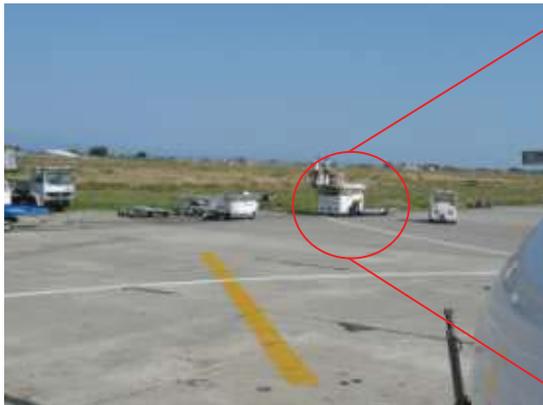
**Picture 4**

At the time when the investigator arrived in Rhodes "Diagoras" Airport on 13 October 2008, the machine had already been moved away from the incident area. Therefore it was not possible to determine the distances and the position of the machine at the moment of the collision, in an exact manner. From the photographs taken on 13 October 2008 by the Airport Authorities personnel and from other sources, the machine occupies a space inside of the white line and its imaginary extension, draws the white circle periphery of the boundary of the aircraft parking position No 8. (Pictures 4 & 5). The area indicated, from the sources mentioned above, that the Containers Loader Machine, with registration plates No 70898, was found at the moment of the incident, is not related to the area that has been given to Goldair Handling, by "Diagoras" Airport, Rhodes, Airport Authorities, for parking their equipment.

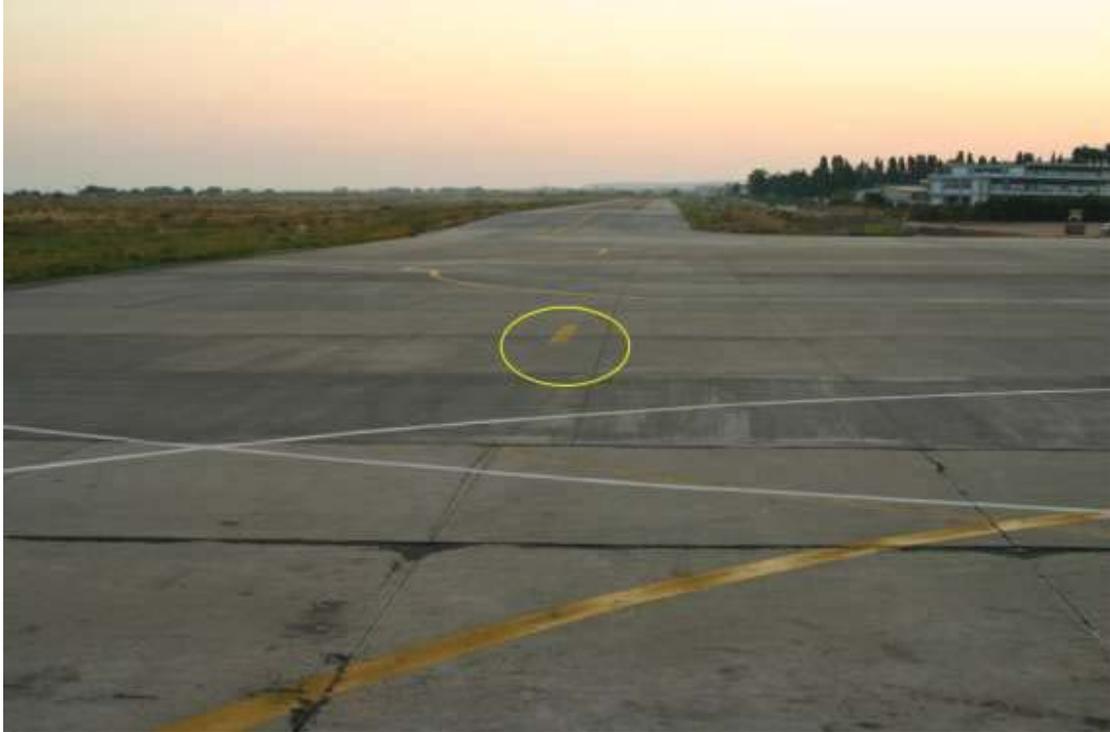
**Picture 6**

The Captain should always have full awareness of the area surrounding the aircraft. Also they must not enter or exit from a parking position without the Marshaller's instructions. In this particular case the Captain states that after the initial right turn lost visual contact with the Marshaller, who states that being on the left side of the airplane and seeing the wrong course being followed, tried, initially with signals, then running in parallel with the airplane to prevent the said course. Thus if the Captain was in doubt about the route he had to follow, he could have looked for the Marshaller, who was to his side and was easy to locate him, or to stop the airplane.

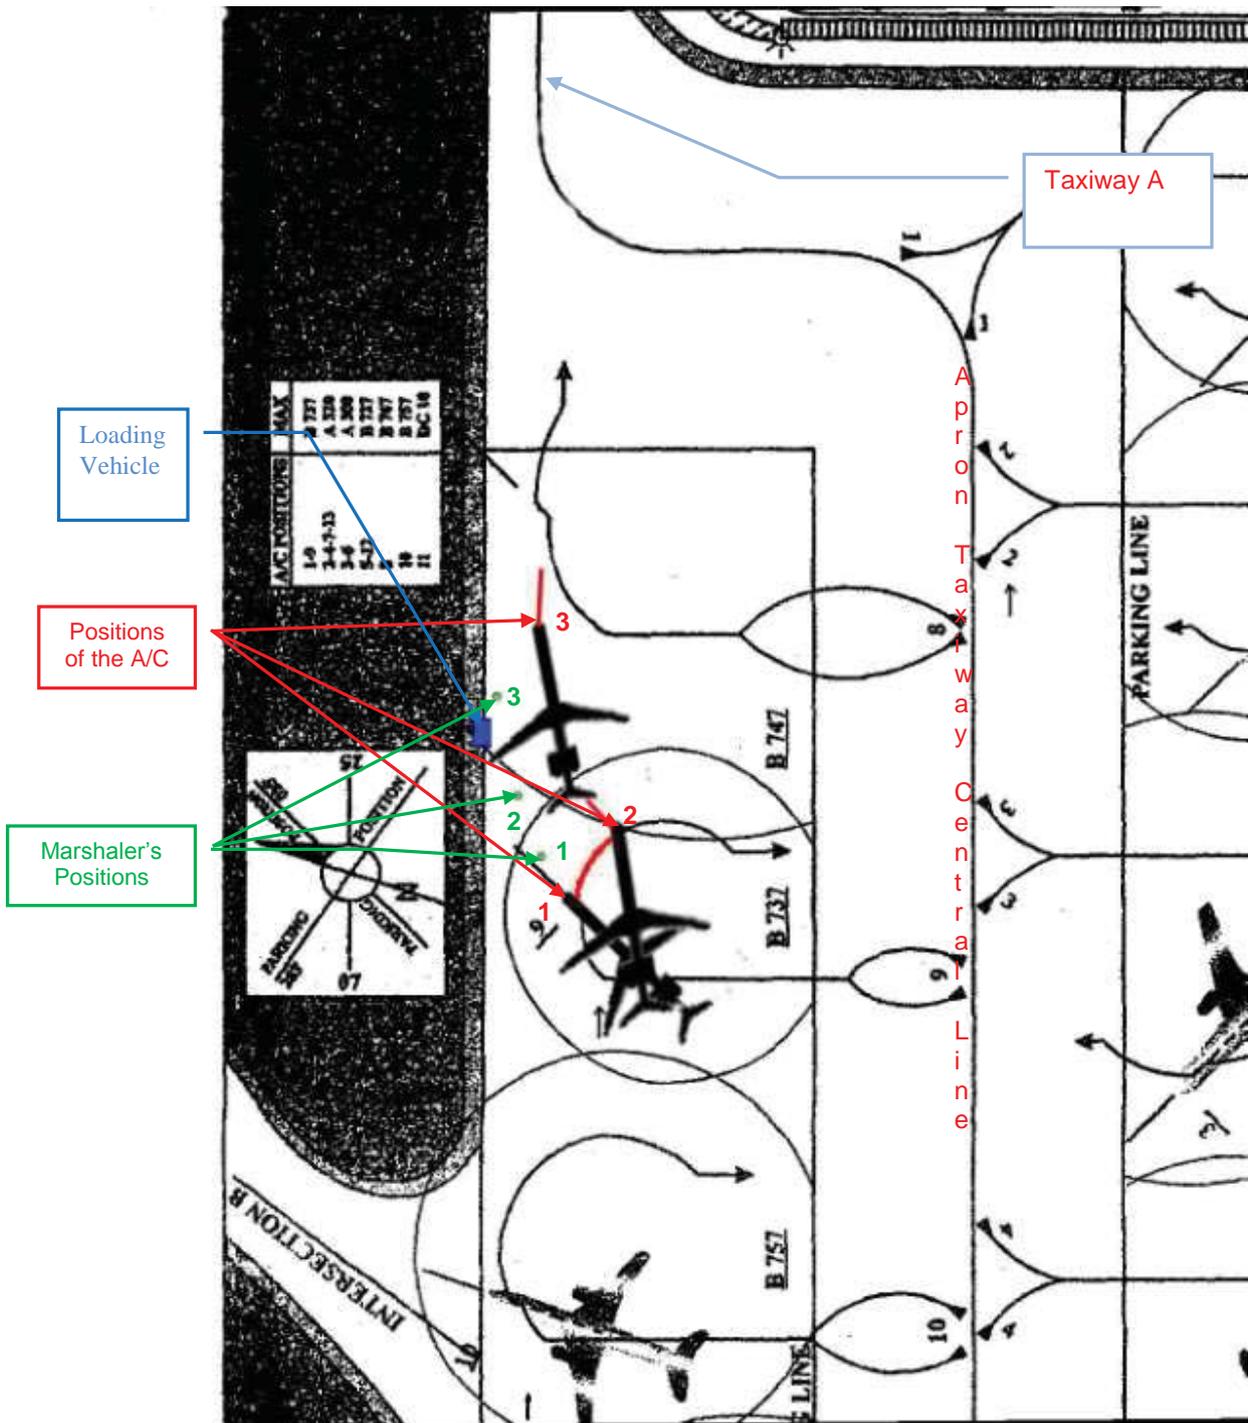
Appendix B

The Marshaller after engines start-up, moved into position in front and to the right side of the aircraft (Appendix B, Position 1), having in sight the Copilot and with the foreseen signals, indicated the right turn direction which the airplane had to follow in order to vacate the parking position and to taxi into the Apron Taxiway. In order to reach the Taxiway A, from the parking position 9 where the airplane was parked, it should execute a right direction turn of about 130° relative to its orientation, to meet the Apron Taxiway Central Line (CL), then with 90° left turn to align with the Apron Taxiway CL and while rolling on it, to execute again 90° left turn and then 90° right turn to enter the Taxiway A.

parking position 8, moved in parallel with the airplane's track trying with signals to warn the crew, without success. The aircraft continued rolling towards Taxiway A and the left hand wing tip collided on the Containers Loader Machine. (See Appendix B)
