**AIR ACCIDENT INVESTIGATION
AND AVIATION SAFETY BOARD
(AAIASB)**

**SERIOUS INCIDENT INVESTIGATION REPORT
AIRBUS AIRCRAFT A320-214
G-EZOC
AT ATHENS INTERNATIONAL AIRPORT
ON 29th SEPTEMBER, 2017**

E01 / 2021

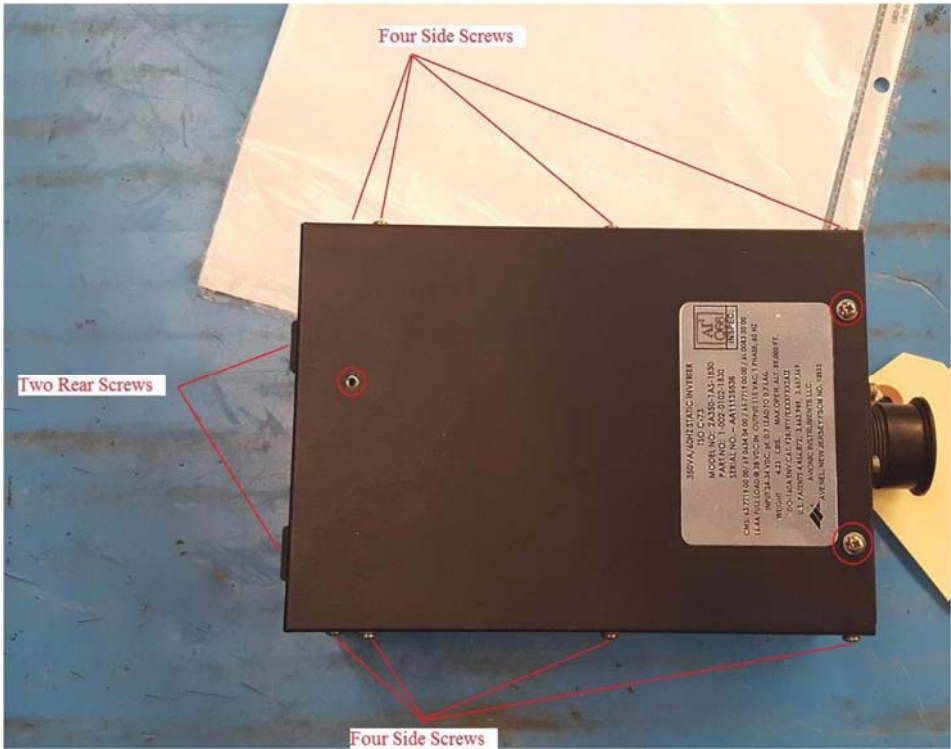
Photo 1: Static Inverter with P/N 1-002-0102-1830

No damages to the aircraft apart from the overheated capacitor inside the static inverter.

The static inverter with (P/N) 1-002-0102-1830 and (S/N) AA11136967 was removed from the a/c and sent to the manufacturer for inspection, the results of which showed that the reason for the smoke was due to overheating of the capacitor C306 inside the static inverter (Photo 2). According to the VSB 1830-25-37 Rev. 0 issued on 13 October 2016, the manufacturer of the static inverter with (P/N) 1-002-0102-1830, Avionic Instruments LLC, recommends modification of those manufactured from 10 September 2012 to 25 November 2014, in which a C306 capacitor from the manufacturer Electrocube Inc. was installed. The modification is to replace capacitor C306 with a similar one from another manufacturer so that there is no operational impact due to possible failure.

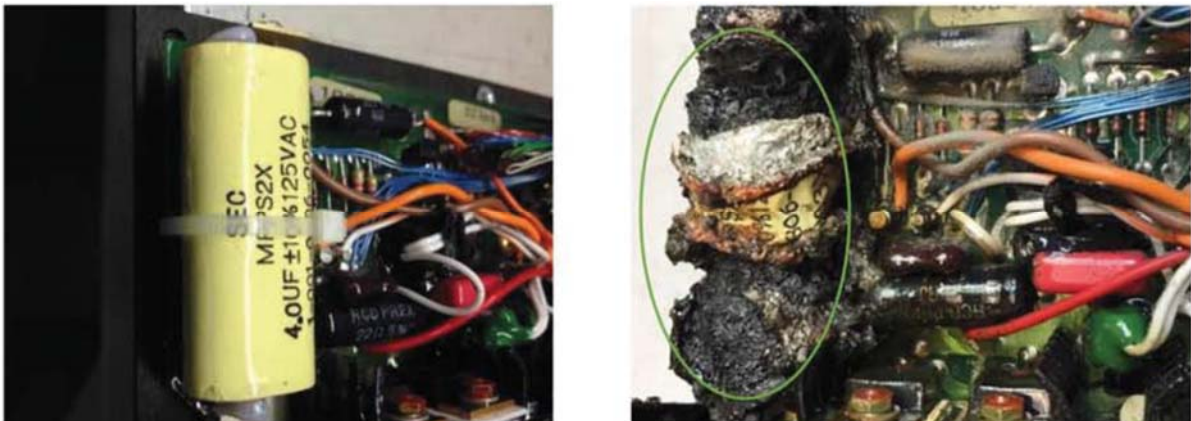
Photo 2: The capacitor C306 before and after overheating.

From 10 September 2012 to 25 November 2014, the manufacturer Avionic Instruments LLC of the above units, supplied the C306 capacitors from the manufacturer Electrocube Inc. and these capacitors were installed in the static inverters with (P/N) 1-002- 0102-1830 and (S/N) from AA11135265 to (S/N) AA11137323. The above capacitor manufacturer had not

subjected these capacitors to burn in test as required. During this test, followed by all capacitor manufacturers, an alternating voltage of 125VAC/400 Hz is applied for at least 24 hours, during which a temperature of 85 °C is developed in the capacitor. The above static inverter with (S/N) AA11136967 that was damaged, was built in July 2014 and according to VSB 1830-25-37 Rev. 0 issued on 13 October 2016, it belonged to the group of those that needed to be modified.

Static Inverter capacitor failure due to overheating.

On 13 October 2016, VSB 1830-25-37 Rev. 0, *“Equipment – Cockpit Additional Electrical Supply – Static Inverter – Capacitor C306 replacement”*, was published on the vendor’s website, which recommended the static inverter to be removed for modification.
