ACCIDENT INVESTIGATION REPORT
INVOLVING THE HELICOPTER SX-HBB
AT THE AREA OF SCHINIAS – MARATHONAS
ON 23 JUNE 2017

**ACCIDENT INVESTIGATION REPORT
10 / 2018**

**involving the Helicopter SX-HBB
at the area of Schinias - Marathonas
on 23 June 2017**

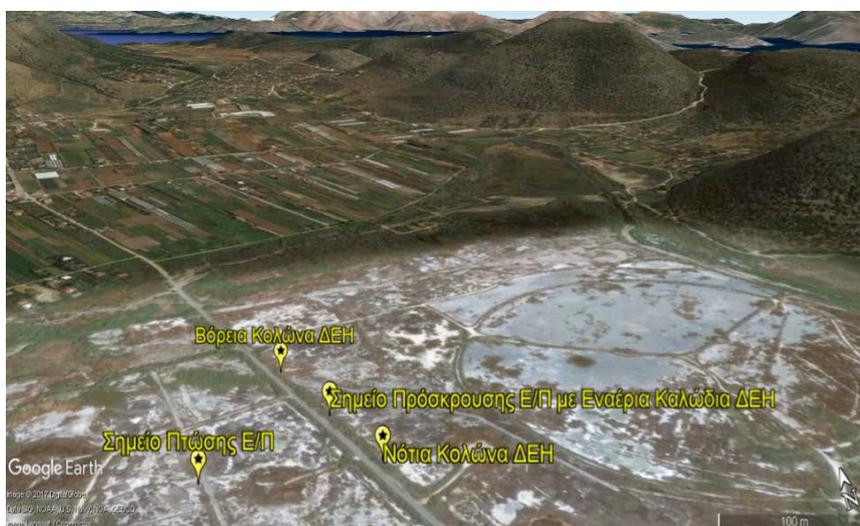
while the student and the security guard of the rowing/canoeing center were video-recording the flight with their mobile phones (the student doing so from the right-hand door glass) the pilot was heard, as reported by the student, saying something like “damn, wires”. As soon as he turned his head forward, there was a sound of impact and the windshield of the helicopter became detached from it. At the same time there was a sound similar to that made when a rotating object comes in contact with a stationary one, as well as a smell similar to that in an electric short-circuit. The helicopter then crashed at a small distance from the broken power lines, in the wetland, following an unsteady flight (veering off to the left – right relative to the Roll Axis) (Photo 2a/b).

Photo 2a: The helicopter’s impact and crash sites

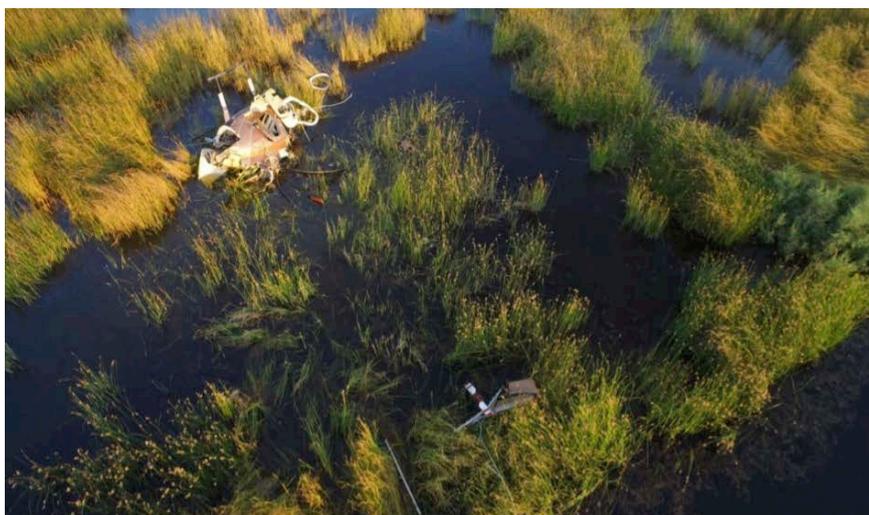
Photo 2b: The helicopter’s crash site

The tail boom was found at a distance of three meters away from the fuselage. The tail rotor together with the tail's vertical and horizontal stabilizer, were found approx. 4 m prior of the fuselage (Photo 2b). The cockpit's windshield that had been detached when the helicopter struck the power lines was not found, whereas the tanks used for the spraying liquid, as well as the spraying nozzles and tubing, were found deformed on the helicopter. The front part of the left landing skid had also been detached from it and was not found.

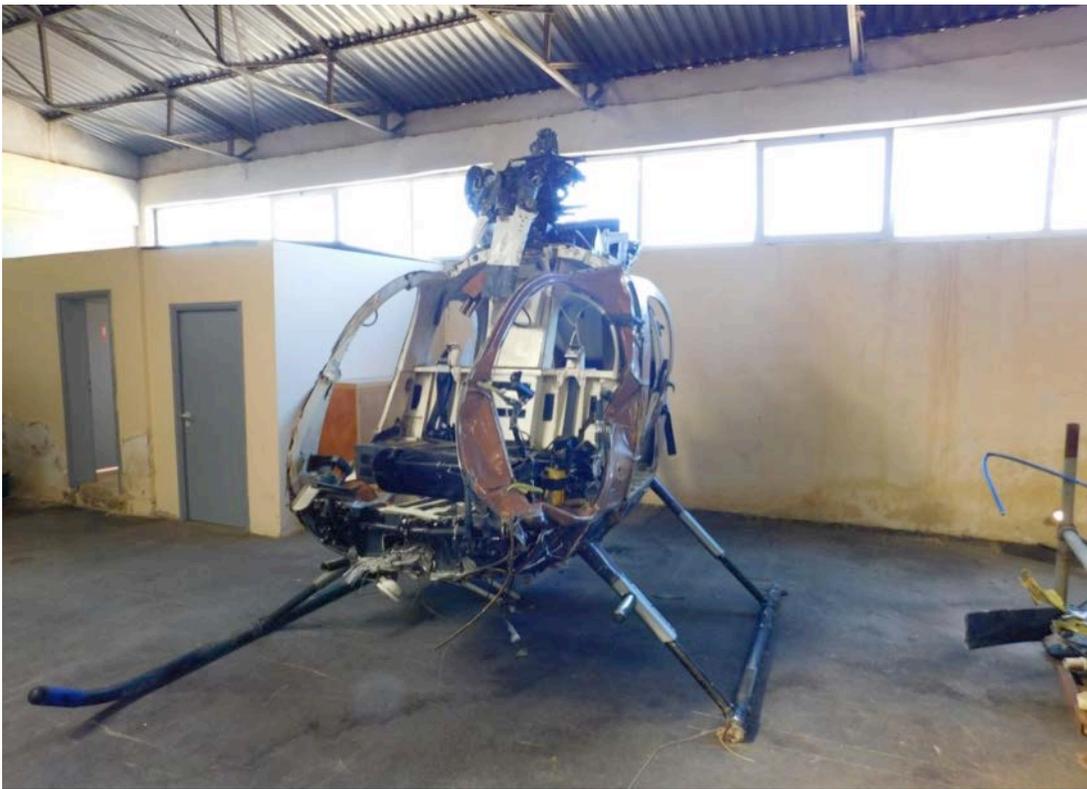
The helicopter was totally destroyed (Photo 2c).

Photo 2c: The helicopter at the hangar of 651 Army Material Depot

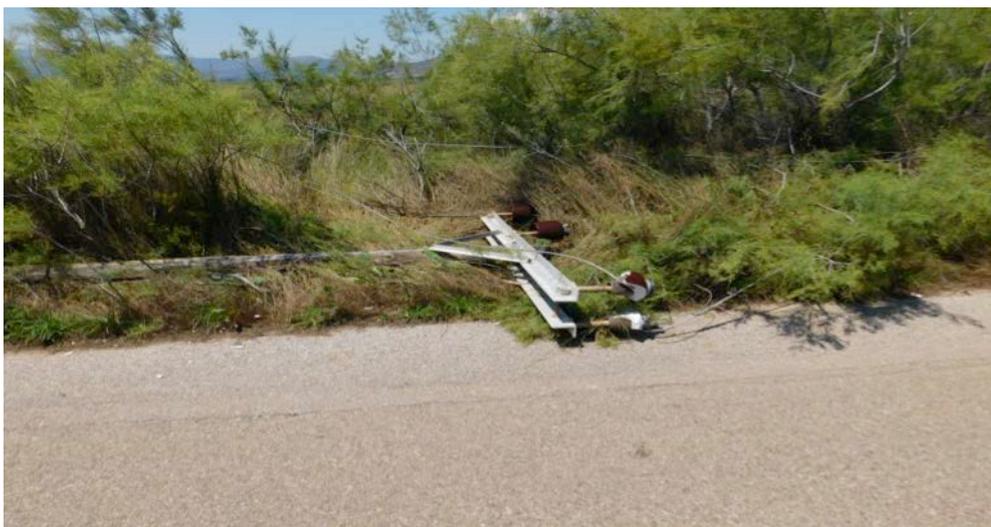
The three power lines suspended on a metallic structure in a “T” configuration at the top of the power transmission wooden poles, broke when the helicopter struck them. Moreover, the power transmission pole located at the left-hand side of the helicopter’s course (Photo 2a, southern wooden pole), broke near its base and fell to the ground (Photo 3).

Photo 3: The power transmission pole, on the ground, following the impact

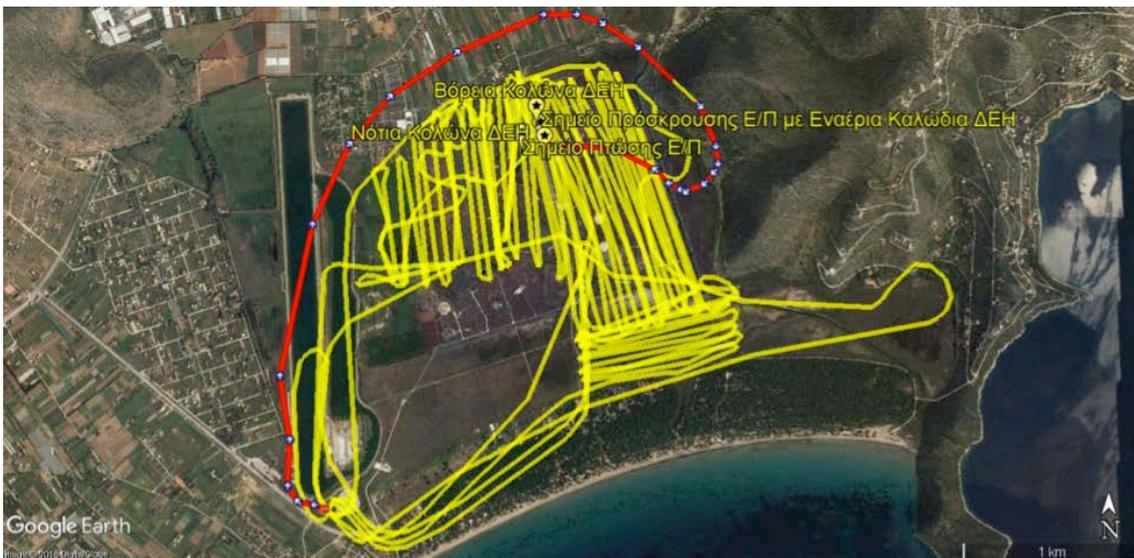
The first and longer segment of the flight (segment AB, Photo 6) was conducted at a considerably higher altitude than the last segment (segment BC, Photo 6) which lasted about 18 sec and was conducted at a low and almost steady altitude of 40 ft above ground.

The yellow line depicts the four aerial spraying flights and the red line shows the last flight which ended with the crash (Photo 6).

Photo 6: Digital plot of the helicopter's flights

it looks that the helicopter had a course approx. 45° relative to the power lines and at a small distance from the power lines (about 200 m) its course became almost perpendicular.
