**AIR ACCIDENT INVESTIGATION AND AVIATION
SAFETY BOARD
(AAIASB)**

**ACCIDENT INVESTIGATION REPORT
INVOLVING B737-800 AIRCRAFT
WITH REGISTRATION EI-FRO
AT THE INTERNATIONAL AIRPORT OF CHANIA, CRETE
ON 23rd DECEMBER 2016**

E03 / 2018

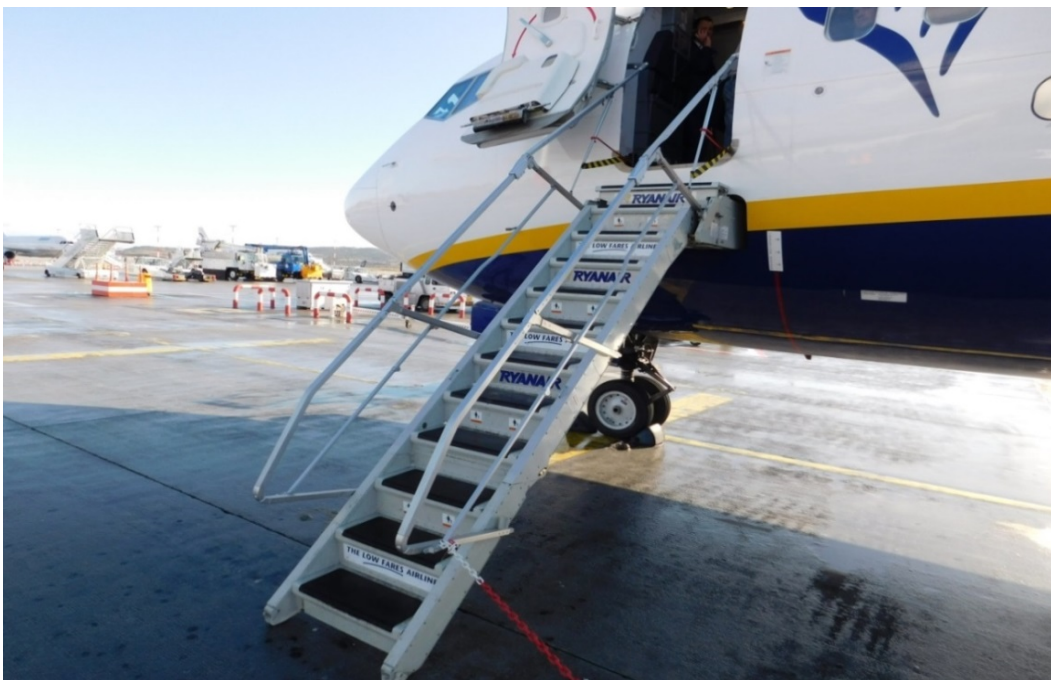
According to the testimony of the fuel company employee, prior to the commencement of the refueling operation, he (the employee) walked up the forward left stair in order to consult with the captain on the quantity of fuel to be delivered. The stair is of the folding type it is a constituent part of the aircraft and opens mechanically both from the outside and from the inside of the aircraft. Part of the handrails is automatically deployed simultaneously with the deployment of the stair, whereas the last section of the handrails, extending over the three last steps, can only be deployed when the door of the aircraft is fully open, since it is supported on the inside of the fuselage, at the point of contact of the door. (Photos 1 & 2).

Photo 1: The forward folding stair of the aircraft fully extended.

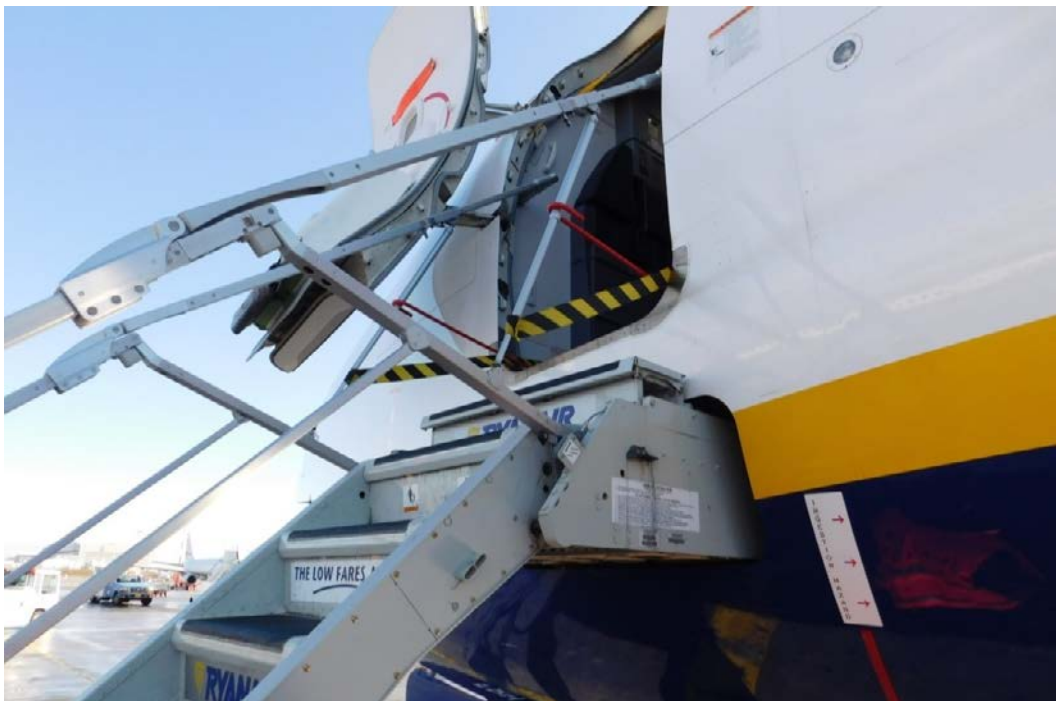
According to his testimony, on the said day and because it was raining none of the above persons was outside the aircraft. Given that there was no one to sign the form and take a copy thereof and due to the fact that there was no way to communicate with the crew of the aircraft, the employee, as per his own testimony, went up to the aircraft himself in order to handle the relevant procedure for the fuel form. It is noted that when the employee walked up the stair the first time, the left forward door was open and the handrails were deployed in position; however, when he went up a second time in order to complete the procedure relevant to the fuel form, the said door was closed at its greater part due to the rain and there was only a small opening at its side, whereas the handrails at the uppermost part of the stair were not deployed.

Photo 2: Uppermost part of the forward folding stair of the aircraft.

moved in the direction opposite to the direction of opening of the door and even though he tried to hold on to the handrail of the folding stair this was not possible given that the handrails at the uppermost part of the stair were stowed. As a result, the employee lost his balance, fell on the ground from a height of about three meters and sustained serious injuries.

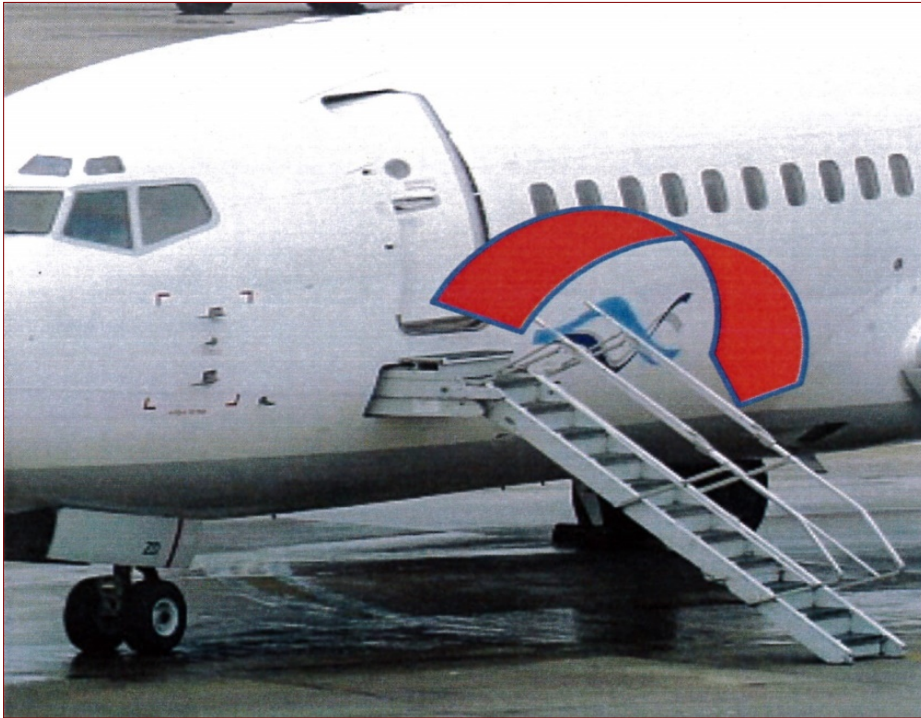
According to the testimony given by the chief flight attendant (No. 1) who opened the door and the testimony of her colleague, a cabin crew member (No. 4), the employee, having knocked on the door of the aircraft and after the crew established that he was outside by looking through the door window, but also through the small opening at the side of the door, given that visibility was poor as a result of the rain, was asked whether he wanted to enter the aircraft. When he replied in the affirmative, he was requested to move back so as not to be hit by the door when opening. The employee was hit by the door and, losing his balance, fell to the ground from a height of about three meters resulting in him sustaining serious injuries (Photo 3).

Photo 3: The direction of fall of the fuel personnel from the folding stair.

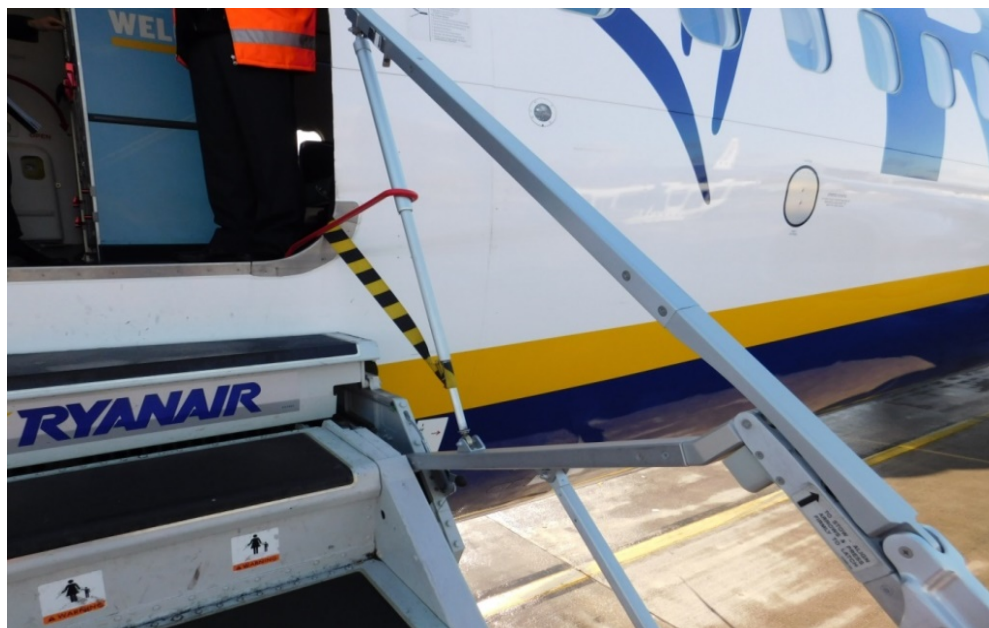
According to the testimony of the fuel company employee, when he reached the last step of the stair and before he had a chance to knock on the door of the aircraft to let the cabin crew know that he was there in order for them to open the door, the door suddenly opened (moving outward) and hit him. He then lost his balance and fell from the stair to the ground, which caused him to sustain serious injuries, even though he wore the requisite equipment for his personal protection. It is noted that in the said folding stair, the last step is narrow (Photo 4) so the person standing on such step for the purpose of knocking on the door to be let in is found in a very short distance from the door of entry to the aircraft.

Photo 4: Uppermost part of the folding stair.

Moreover, when someone is on the last step of the folding stair, they must exercise particular care so as not to lose their balance when moving backwards to steer clear of the door, in order to avoid being hit by it when it opens, as they have to go down one step.

The fact that the handrails at the top part of the stair were not extended was consequent to the fact that the door remained almost closed, as prescribed in the airline instructions in order to avoid the ingress of rainwater inside the aircraft.
