ACCIDENT INVESTIGATION REPORT
INVOLVING THE HELICOPTER SX-HBB
AT THE AREA OF SCHINIAS – MARATHONAS
ON 23 JUNE 2017

**ACCIDENT INVESTIGATION REPORT
10 / 2018**

**involving the Helicopter SX-HBB
at the area of Schinias - Marathonas
on 23 June 2017**

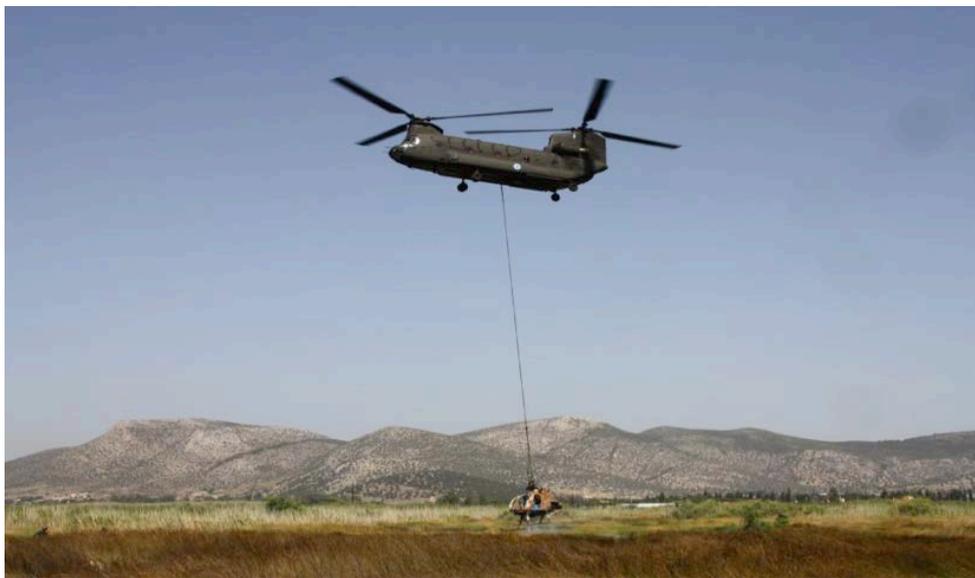
The helicopter was recovered (Photo 5) with the assistance of Armed Forces units and in particular:

Photo 5: A scene from the helicopter recovery operation
